# Manhole Inspection Summary

Manhole # S53C\_\_051MH

Insp Date: **6/12/08 2:17 PM**

**Location** Address: **rear 24 n east ave**

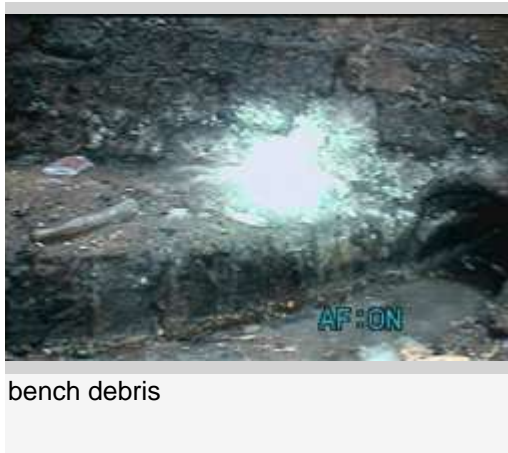
Defect 5

Condition: ☐ Sound ☐ Cracked ☐ Root Intrusion ☐ Deteriorated ☐ Leaks ☒ **Debris**

bench debris

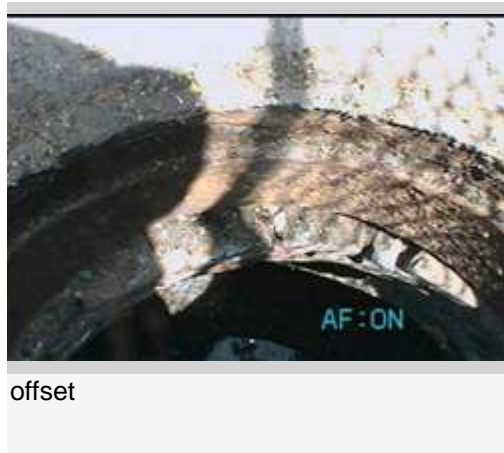
Defect 4

**Frame** Offset: **3** (in.) Condition: ☒ Sound ☐ Cracked ☐ Leaks

offset

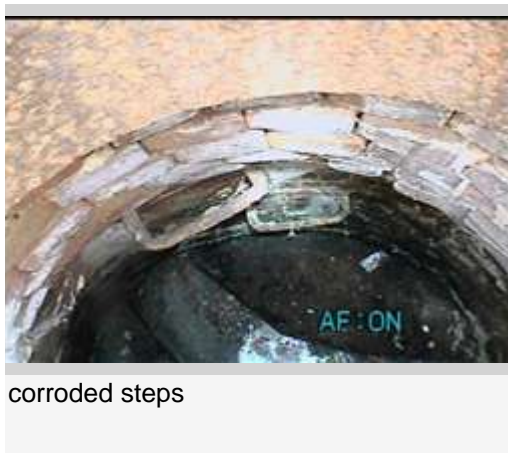
Defect 3

**Steps** Count: **2** Missing: **0** ☒ **Corroded**

corroded steps

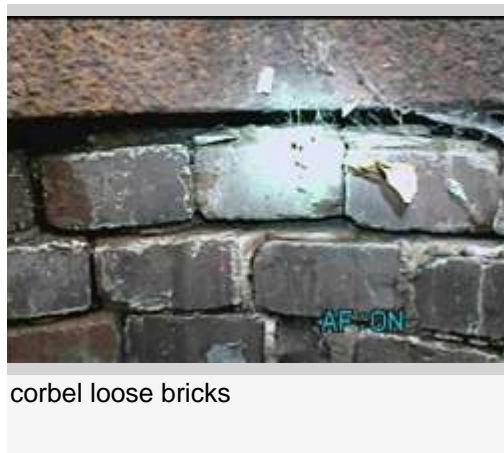
Defect 2

Condition: ☐ Sound ☐ Cracked ☐ Root Intrusion ☒ **Loose Brick** ☐ Deteriorated

corbel loose bricks

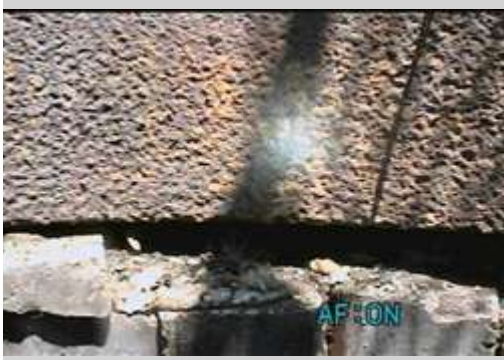
### Defect 1

Condition: ☐ Sound ☐ Cracked ☐ Root Intrusion ☒ **Loose Brick** ☐ Deteriorated

chimney loose bricks, frame adj

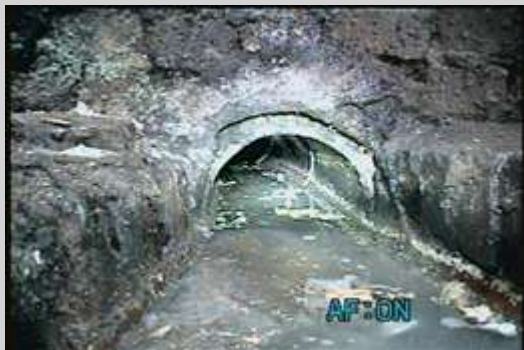
12 O'Clock Outflow

Invert Depth: **6.77** (ft.) Flow Characteristics: **Slow**

Infiltration: **None** Pipe Seal Cond: **Unknown**

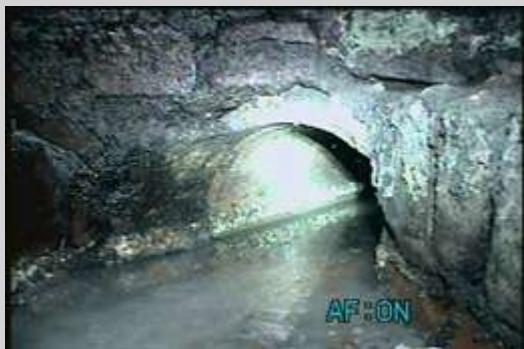
7 O'Clock Inflow

Invert Depth: **6.55** (ft.) Flow Characteristics: **Slow**

Infiltration: **None** Pipe Seal Cond: **Unknown**
